# High Voltage Testing Services Gas Plant

### HV COMPONENT REPLACEMENT

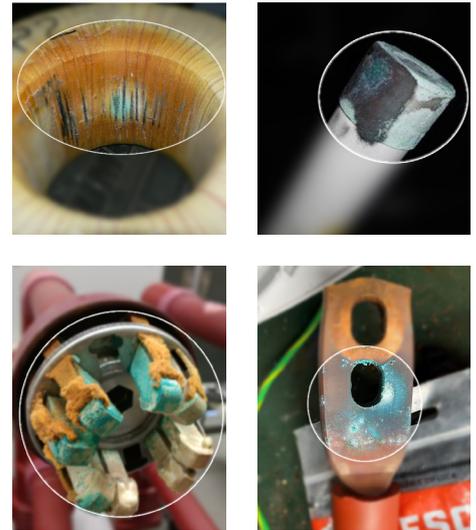
During the initial isolation and inspection of the site assets, corrosion and oxidation were observed and noted on several components inside the switchgear cubicle. A by-product of Partial Discharge is the release of ozone and nitrous oxide, this commonly results in visible corrosion and oxidation on the surface of HV components.

The root cause of this PD was likely high precipitation and faulty cubicle heater.

*Corrosion & Oxidisation*

- Entire site's condition assessed in 1 day utilising concurrent testing
- Discharging CT's and VT's identified
- Switchgear cubicle heater repaired
- Follow-up testing completed with the site deemed REFCL compliant
- Functionality of the HV network ultimately upgraded

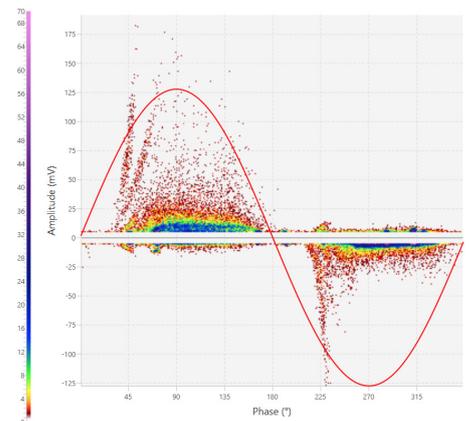
High Voltage PD testing confirmed significant discharge was occurring from multiple locations in the switchgear. Using a combination of PD time-of-flight techniques, including electromagnetic and acoustic sensors, the offending components were successfully pinpointed. It was determined that the remainder of the switchgear was in good condition with no PD evident.

*PD Phase Pattern from discharging switchgear*
