# Predicting HV cable failures and completing the test cycle

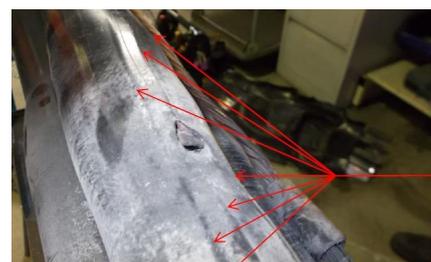
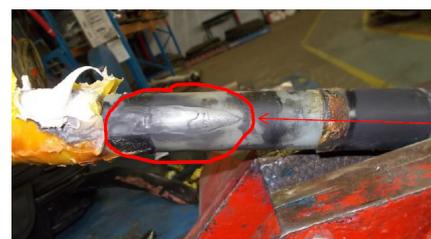
The cables identified in the table above were not replaced and in 2018, 5 years after initial detection, there were two failures at the precise locations identified, resulting in 68 hours and \$9.5 million in lost production.

Cable failure

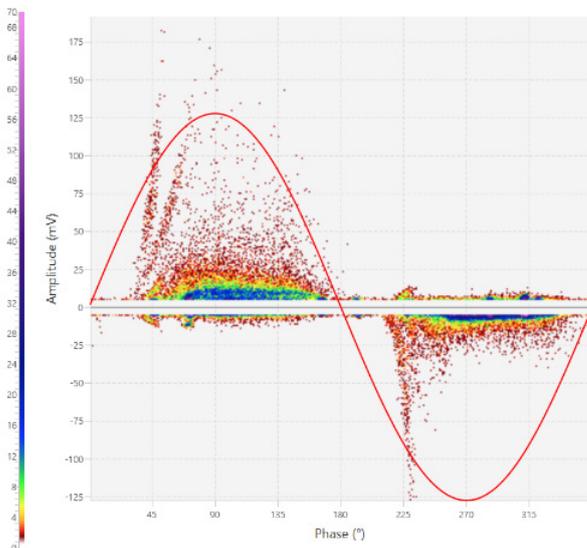
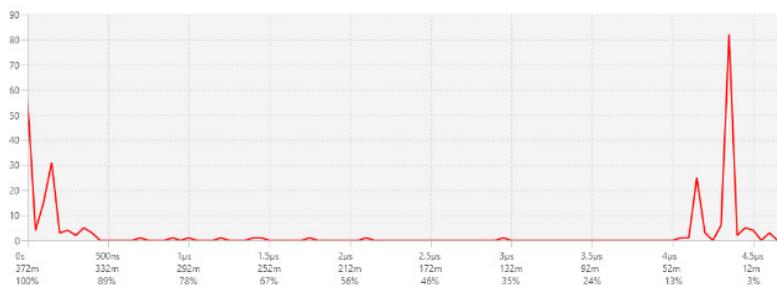
PD Heatmap and location plot

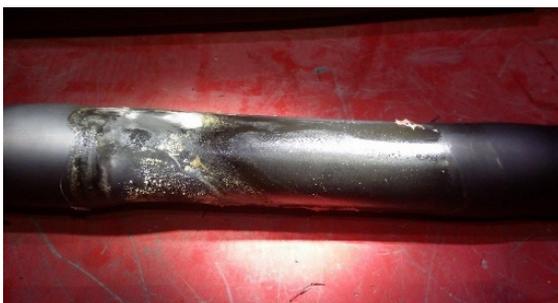
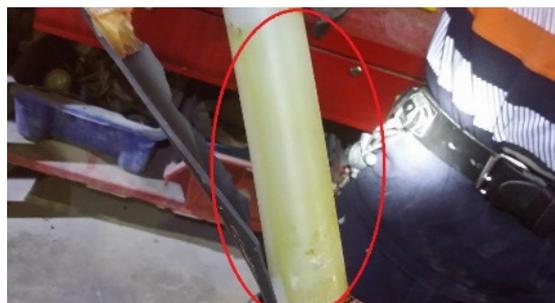
Following these improvements several areas on the cable ring were proactively replaced during scheduled shutdowns based upon advice from LIVE HV. Evidence of discharge was clearly visible where the repairs were made as shown below. Without action these would have definitely resulted in failure.

Example of imminent failure detected and repaired prior to failure
